# Reopening side channels along the Saône in Jassans-Riottier

Project owner	Voies navigables de France (VNF - French waterways authority)
Category	Improvement of waterways
Type of operation	Creation or reopening of alluvial wetlands
Type of environment	Lowland rivers
Issues at stake (water, biodiversity, climate)	Good status of habitats, river continuity
Start of operation	September 2007
End of operation	April 2008
Length of river affected by the works	500 m

Name	Saône River
Distance to source	408 km
Mean width	215 m
Mean discharge	400 m <sup>3</sup> /s

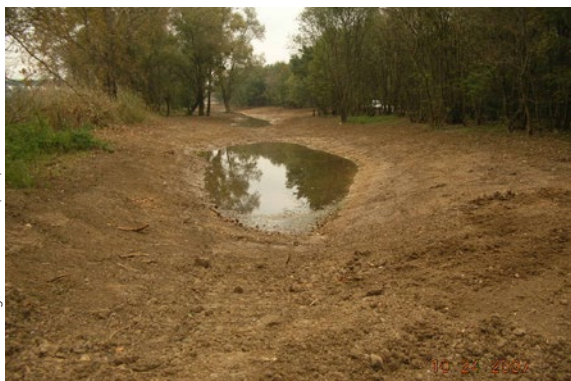
Earthwork to restore a side channel and ponds. October 2007.

Works were done on the remains of wetlands that still existed along the Saône. In 2007, secondary channels and ponds that were continuously or intermittently linked to the Saône were restored by moving 12,000 m<sup>3</sup> of earth.

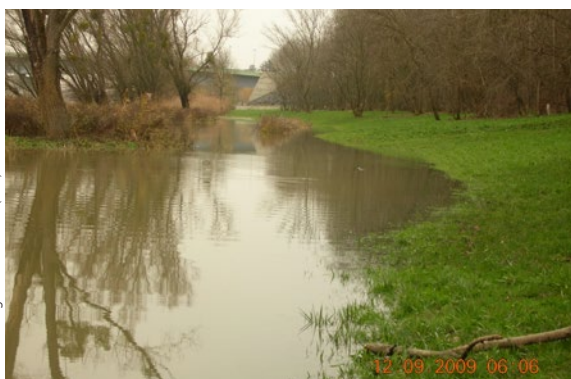
Flooding of the restored side channel. December 2009.

The topographic profiles prepared in 2009 revealed a high level of local sedimentation causing a narrowing of the side channel. On the basis of the results from 2010 to 2012, this sedimentation is apparently caused by readjustments on the worked site where successive floods and the wakes of ships even out the profile of the side channels.

However, the analysis also revealed that the wakes of ships produced effects in the side channel and represented a significant pressure on the environment by limiting biological development. Fine sediment in the side channel was regularly resuspended in the water by the wakes, which may reduce the environmental value of the area.

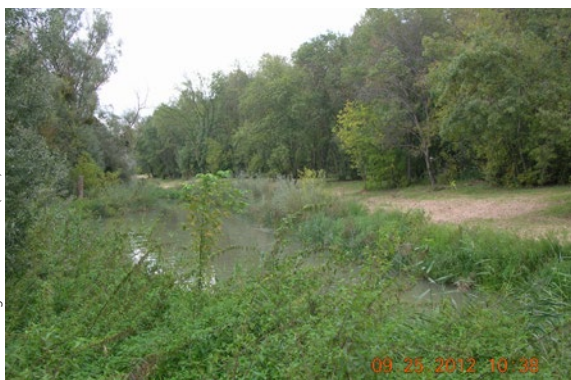
The vegetation in the restored side channel had developed well 4.5 years after the works. September 2012.

The aquatic vegetation in the continuously filled pond underwent considerable change with respect to the observations made from 2009 to 2011. The dominant Nuttall's pondweed, an invasive alien species, gave way to significant development of rigid hornwort, a native species. The number of inventoried plant species remained virtually identical. A stabilisation process would seem to be under way in some of the side channels.

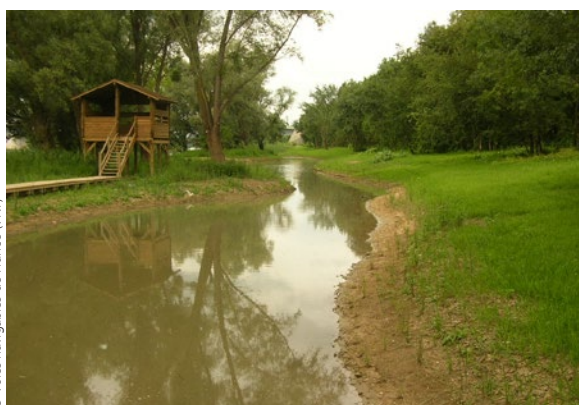
Observation hut for wildlife that burned in November 2008 and was replaced by an elevated boardwalk. July 2008.

In order to enhance the value of the wetlands in the eyes of the general public, the "Porte Ouest de la Dombes" intermunicipal association invested in facilities to welcome the public in the framework of a development programme for the Saône banks. An elevated boardwalk provides access deep into the wetlands and to an observation platform in the middle of the reed bed.
